THE CITY OF DAWSON

AGENDA - COUNCIL MEETING #C21-25 WEDNESDAY, December 8, 2021 at 7:00 p.m. Council Chambers, City of Dawson Office

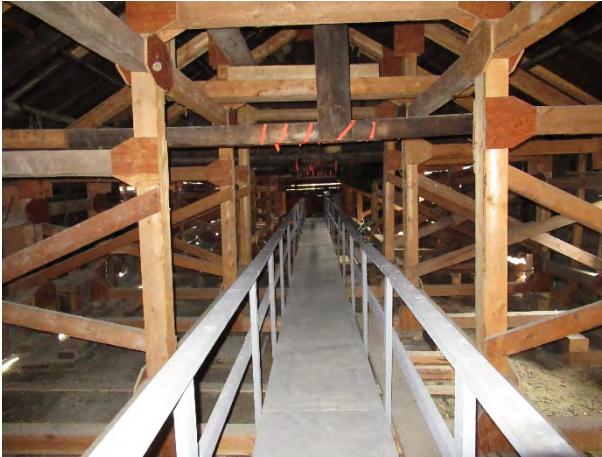
Figure 4-4: General overview of interior frame and central walking aisle.

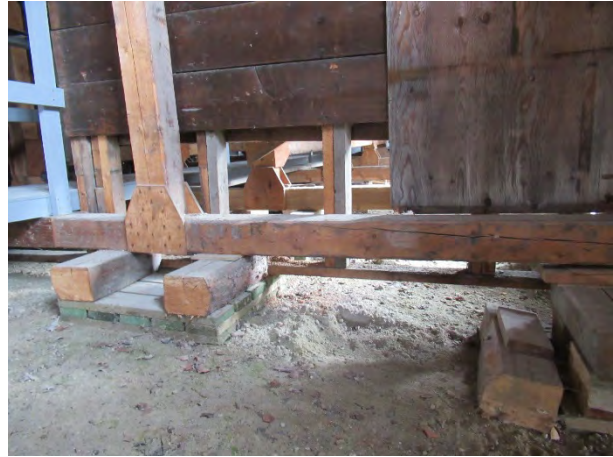
Figure 4-5: Minimal shimming along the center of the interior frame.

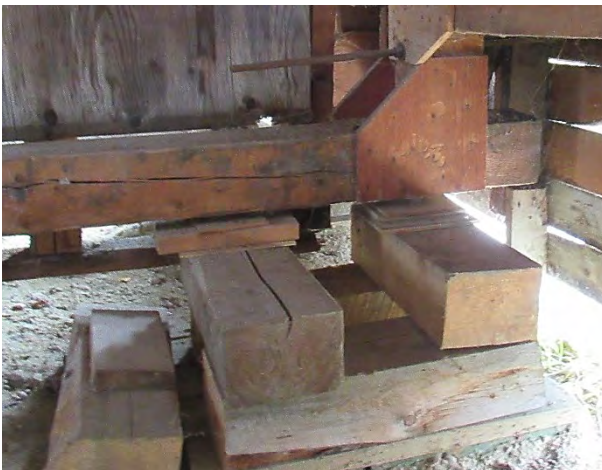
Figure 4-6: Concentration of shims along the south elevation of the interior frame.

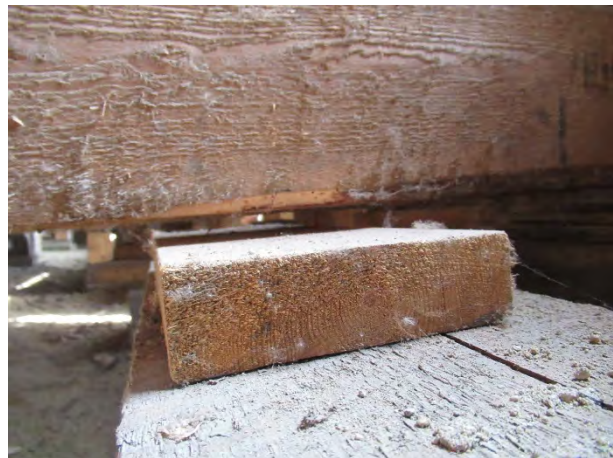
Figure 4-7: Shimming along the south and north elevations was observed to be loose. Note the gap between the shims and the underside of the interior frame.

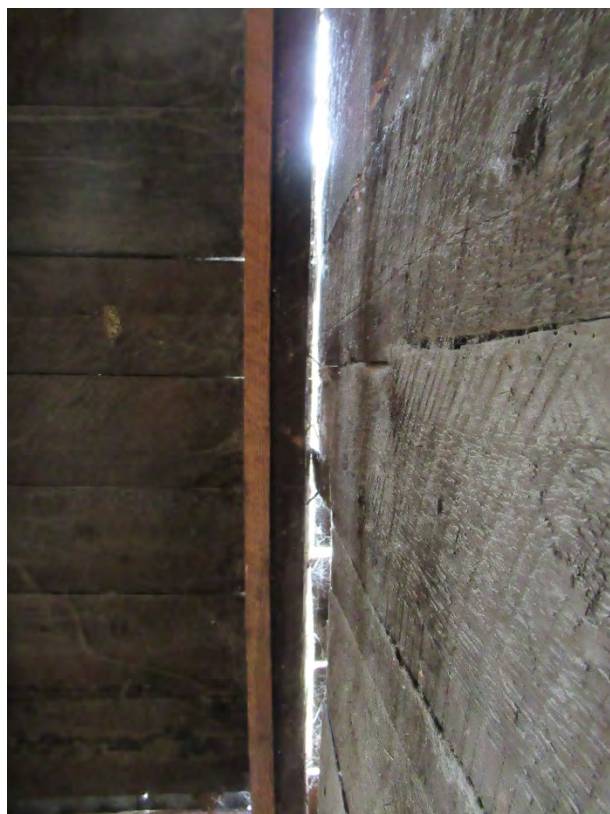
Figure 4-8: No connection between the exterior wall structures was observed between the first and second structure.

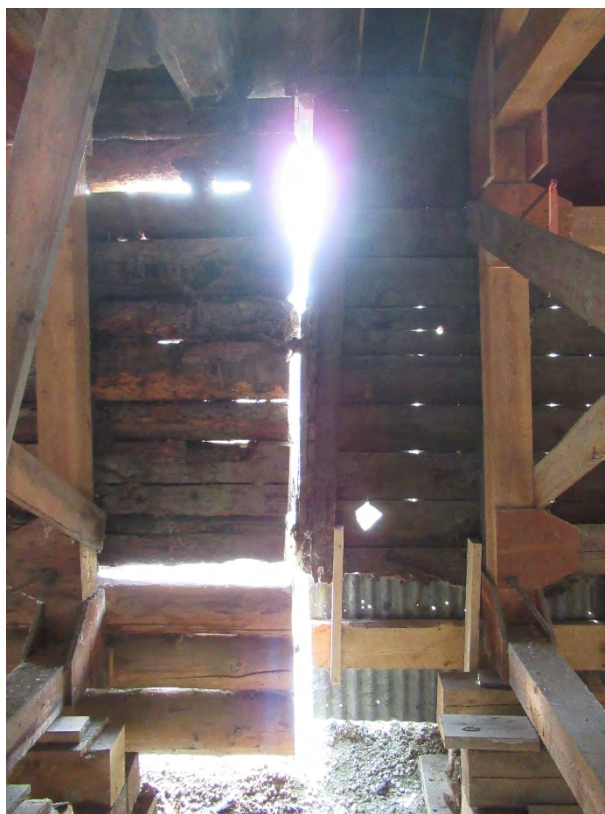
Figure 4-9: No connection between the exterior wall structures was observed between the third and fourth structure.

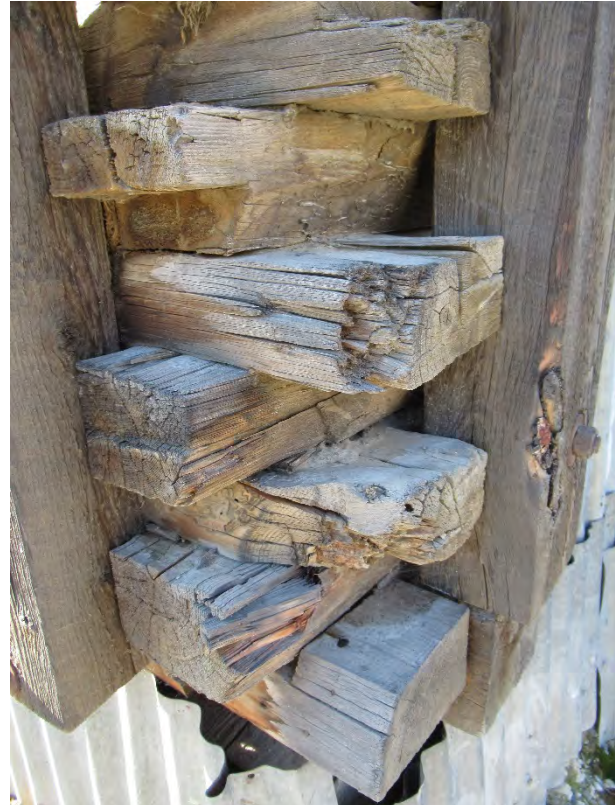
Figure 4-11: Deteriorated log ends on the fourth structure.

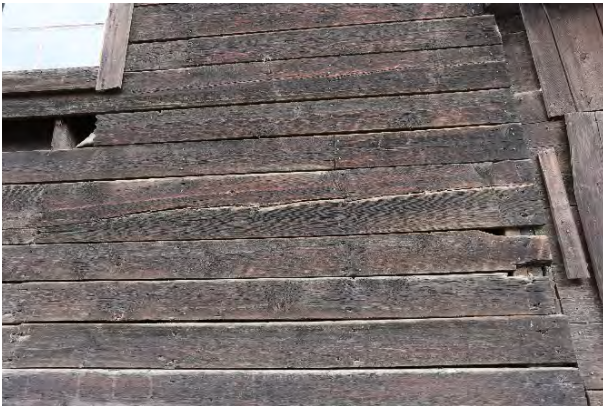
Figure 4-20: Detail of the building envelope condition on the south elevation of Area 1. [PCA, 2018]

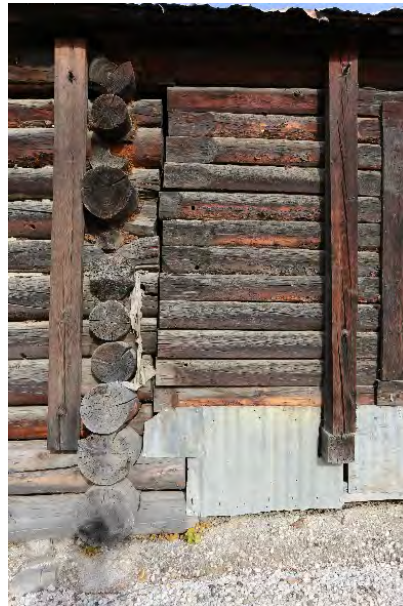
Figure 4-21: Detail of the building envelope on the south elevation depicting various construction styles, previous repairs and materials (at Area 3 and Area 4). [PCA, 2018]

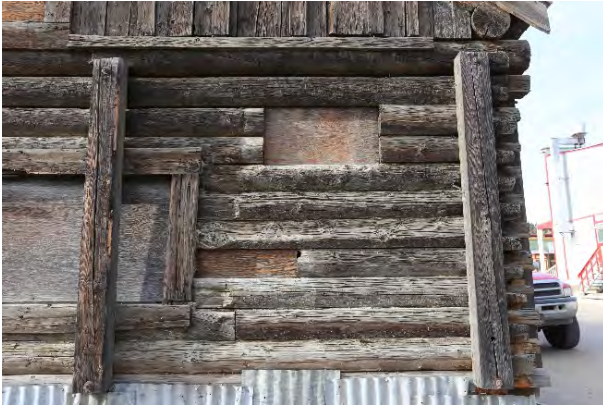
Figure 4-22: Detail of the building envelope condition on the east elevation of Area 4. [PCA, 2018]

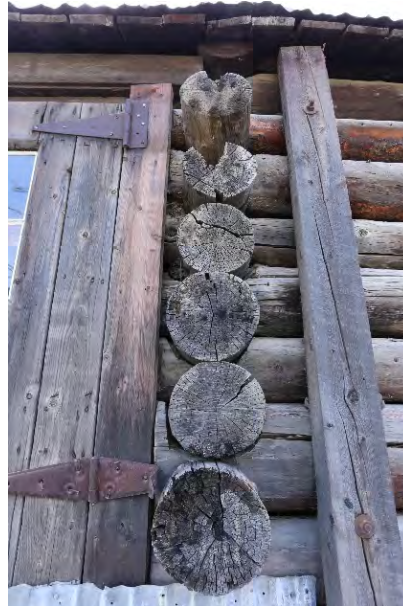
Figure 4-23: Detail of the building envelope condition on the north elevation of Area 4. [PCA, 2018]

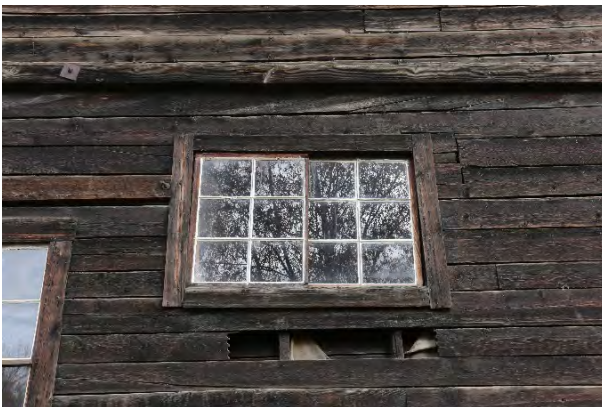
Figure 4-34: This double hung window found on the south elevation of Area 1 has been installed on its side. [PCA, 2018]

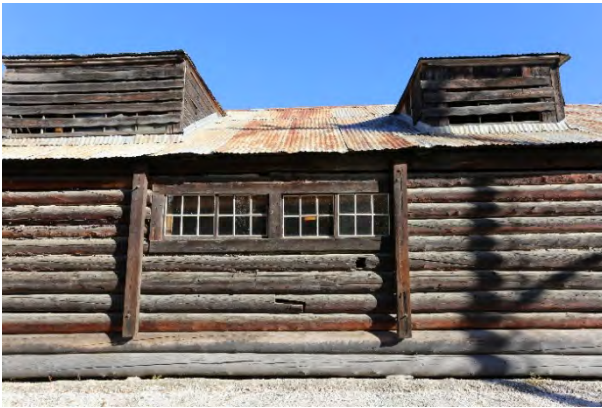
Figure 4-36: Various roofing configurations found on the south elevation of Area 3. [PCA, 2018]

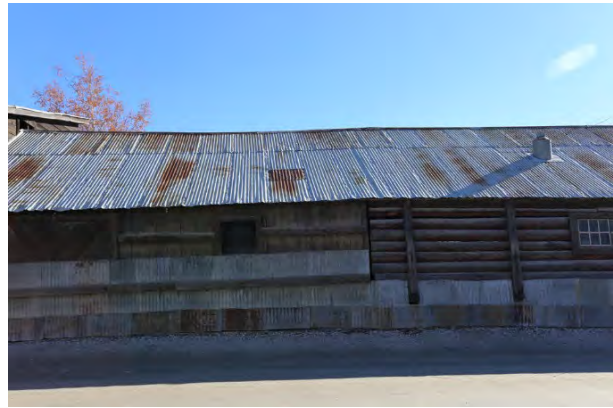
Figure 4-37: Roofing configuration found on the north elevation between Areas 3 and 4. [PCA, 2018]

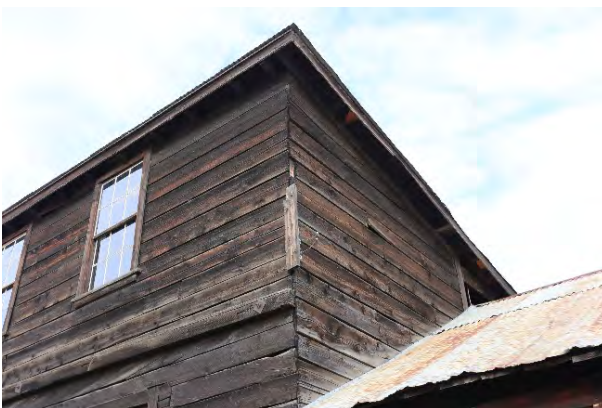
Figure 4-38: Condition of the roofing and fascia on the south elevation of the two storey portion of Billy Biggs. [PCA, 2018]

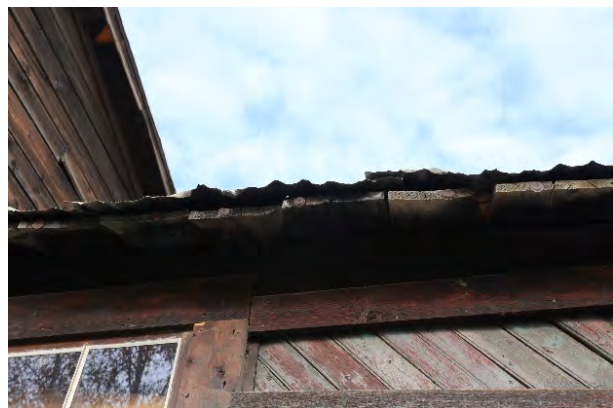
Figure 4-39: Detailed view of the roofing construction as seen on the south elevation of Area 2. [PCA, 2018]

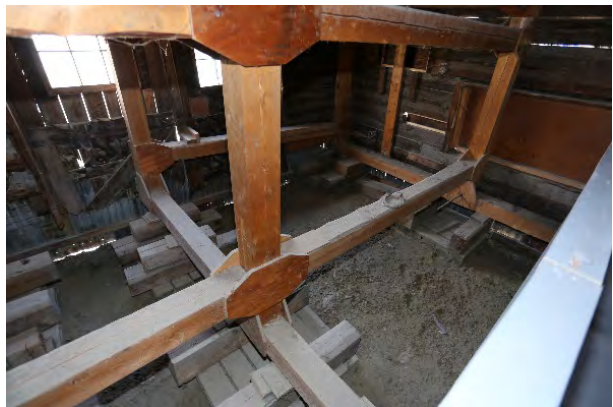
Figure 4-45: Typical flooring and bracing condition as found in Area 4. [PCA, 2018]

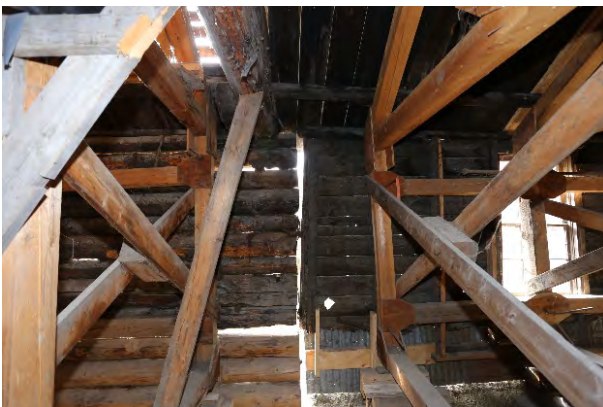
Figure 4-46: Interior view looking south of the junction between Areas 2 and 3. Previous log repairs are seen in the lower left of the photo. [PCA, 2018]

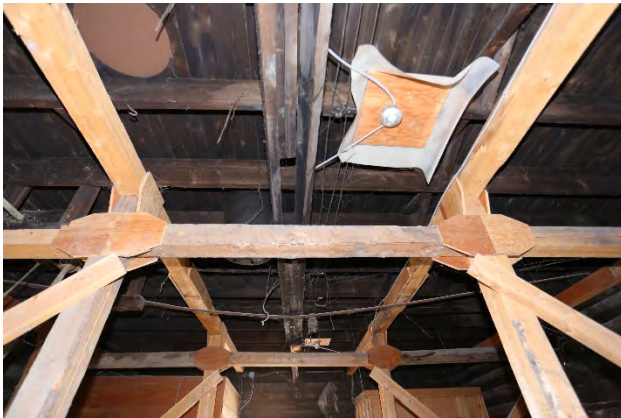
Figure 4-49: Heat Detector (Restorable)

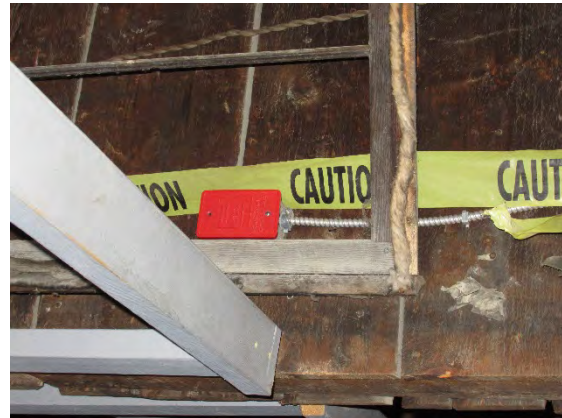
Figure 4-50: Initiating Circuit End-of-Line Resistor

The circuit wiring is installed in a Class B style with an end-of-lines resistor located in junction boxes at the end of the circuit. The initiating circuits are No. 14 AWG (RW-90) cable type conductors and are installed in BX, flexible low voltage armoured cable. They appeared to be properly secured and fastened. This type of wiring method is permitted under Rule 32-102.(2) of the 2015 CEC (CSA 22.1) for buildings of combustible construction.
