# City of Dawson Aquifer and Wellhead Protection Plan

PRESENTED TO  
**Government of Yukon, Community Services**

OCTOBER 11, 2017  
ISSUED FOR USE  
FILE: ENW.WENW03020-01

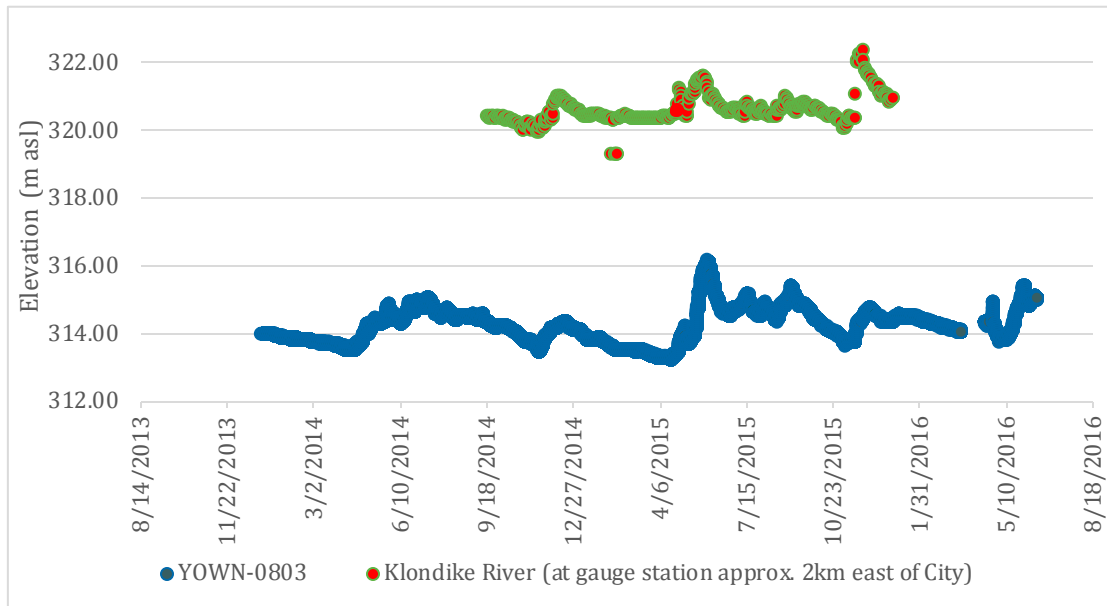
**Figure 5-1: Comparison of DCA and Klondike River Elevations (2014 – 2016)**

Groundwater flow in the relatively shallow unconfined DCA is considered by Tetra Tech to be dominated by surface water recharge that infiltrates through the river bank and sediments from the adjacent Klondike and Yukon rivers. Recharge to the DCA through the bedrock aquifer, surface infiltration or inflow from seasonally thawed active zones in the permafrost areas bounding the DCA to the north and east is expected, although volumes are considered to be minor in proportion to river water recharge. Supporting this, there are strong similarities in the shape of the groundwater and surface water hydrographs for the Klondike River and at monitoring well YOWN-0803 (Figure 5-1; AECOM, 2009). This indicates a hydraulic connection between the DCA and the Klondike River (and by extension the Yukon River), and that this connection extends at least 135 m inland. AECOM (2009) reported a time lag of approximately two days between the surface water level variations and the associated groundwater response in the production wells.

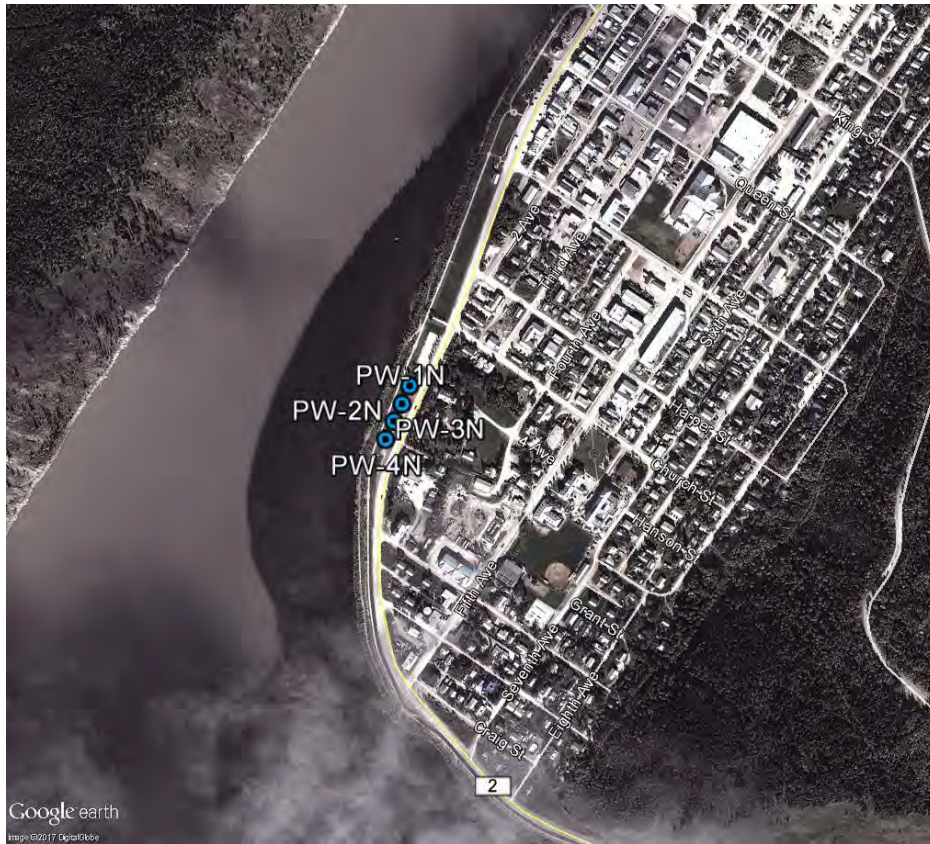
**Figure 7-1: Yukon River/Klondike River Confluence – High River Level**

Based on modelling results, Tetra Tech estimates that approximately 90% of water pumped by the wells is drawn from the Yukon River and the capture zone defined to the west. Approximately 5% of water is drawn from the capture zone extending to the east and south and ultimately from the Klondike River. The remaining 5% is from recharge of precipitation, overland flow and horizontal leakage. While geographically the four wells are inferred to draw a significant proportion of their water directly from the Yukon River, review of aerial images indicates that under high water levels, at the confluence of the two rivers, water from the Klondike River flows with little mixing almost mid-way across the Yukon River and water from the two rivers does not appear to fully mix until several hundred metres downstream of the wells (Figure 7-1).

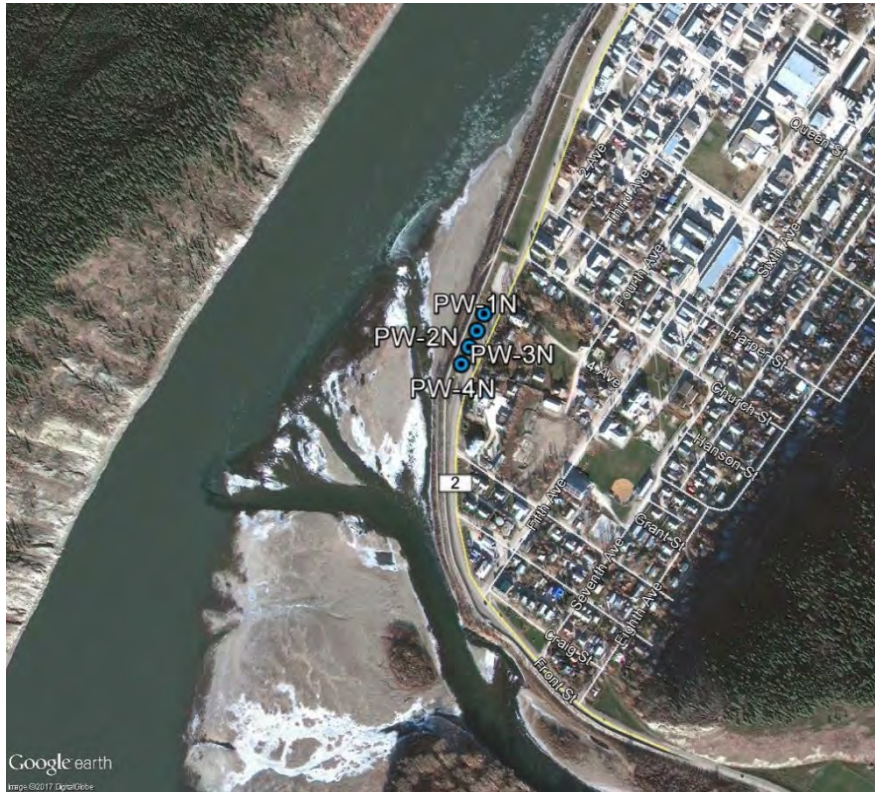
Figure 7-2: Yukon River/Klondike River Confluence – Low River Level

Under low river level conditions, a gravel bar at the confluence of the two rivers is exposed to approximately mid-way across the Yukon River (Figure 7-2). The bar diverts Yukon River flow to the west and away from the wells, while the Klondike River flows along several channels through the bar, one aligned almost directly past the wells.

Based on these observations, Tetra Tech considers that there is effectively no contribution from Yukon River water (i.e., water sourced from upstream of the confluence) to the four water supply wells and therefore the capture zone does not extend to the southwest along this water body.

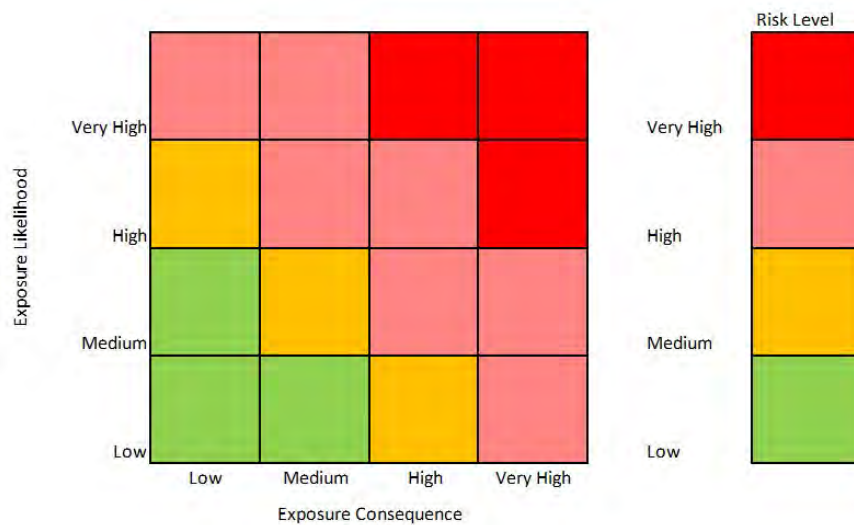
**Figure 7-4: Risk Assessment Matrix**

Risk to the well users was evaluated for each of the hazards identified using the Risk Matrix shown in Figure 7-4.

The following factors were used to define the categories of exposure likelihood and exposure consequence:

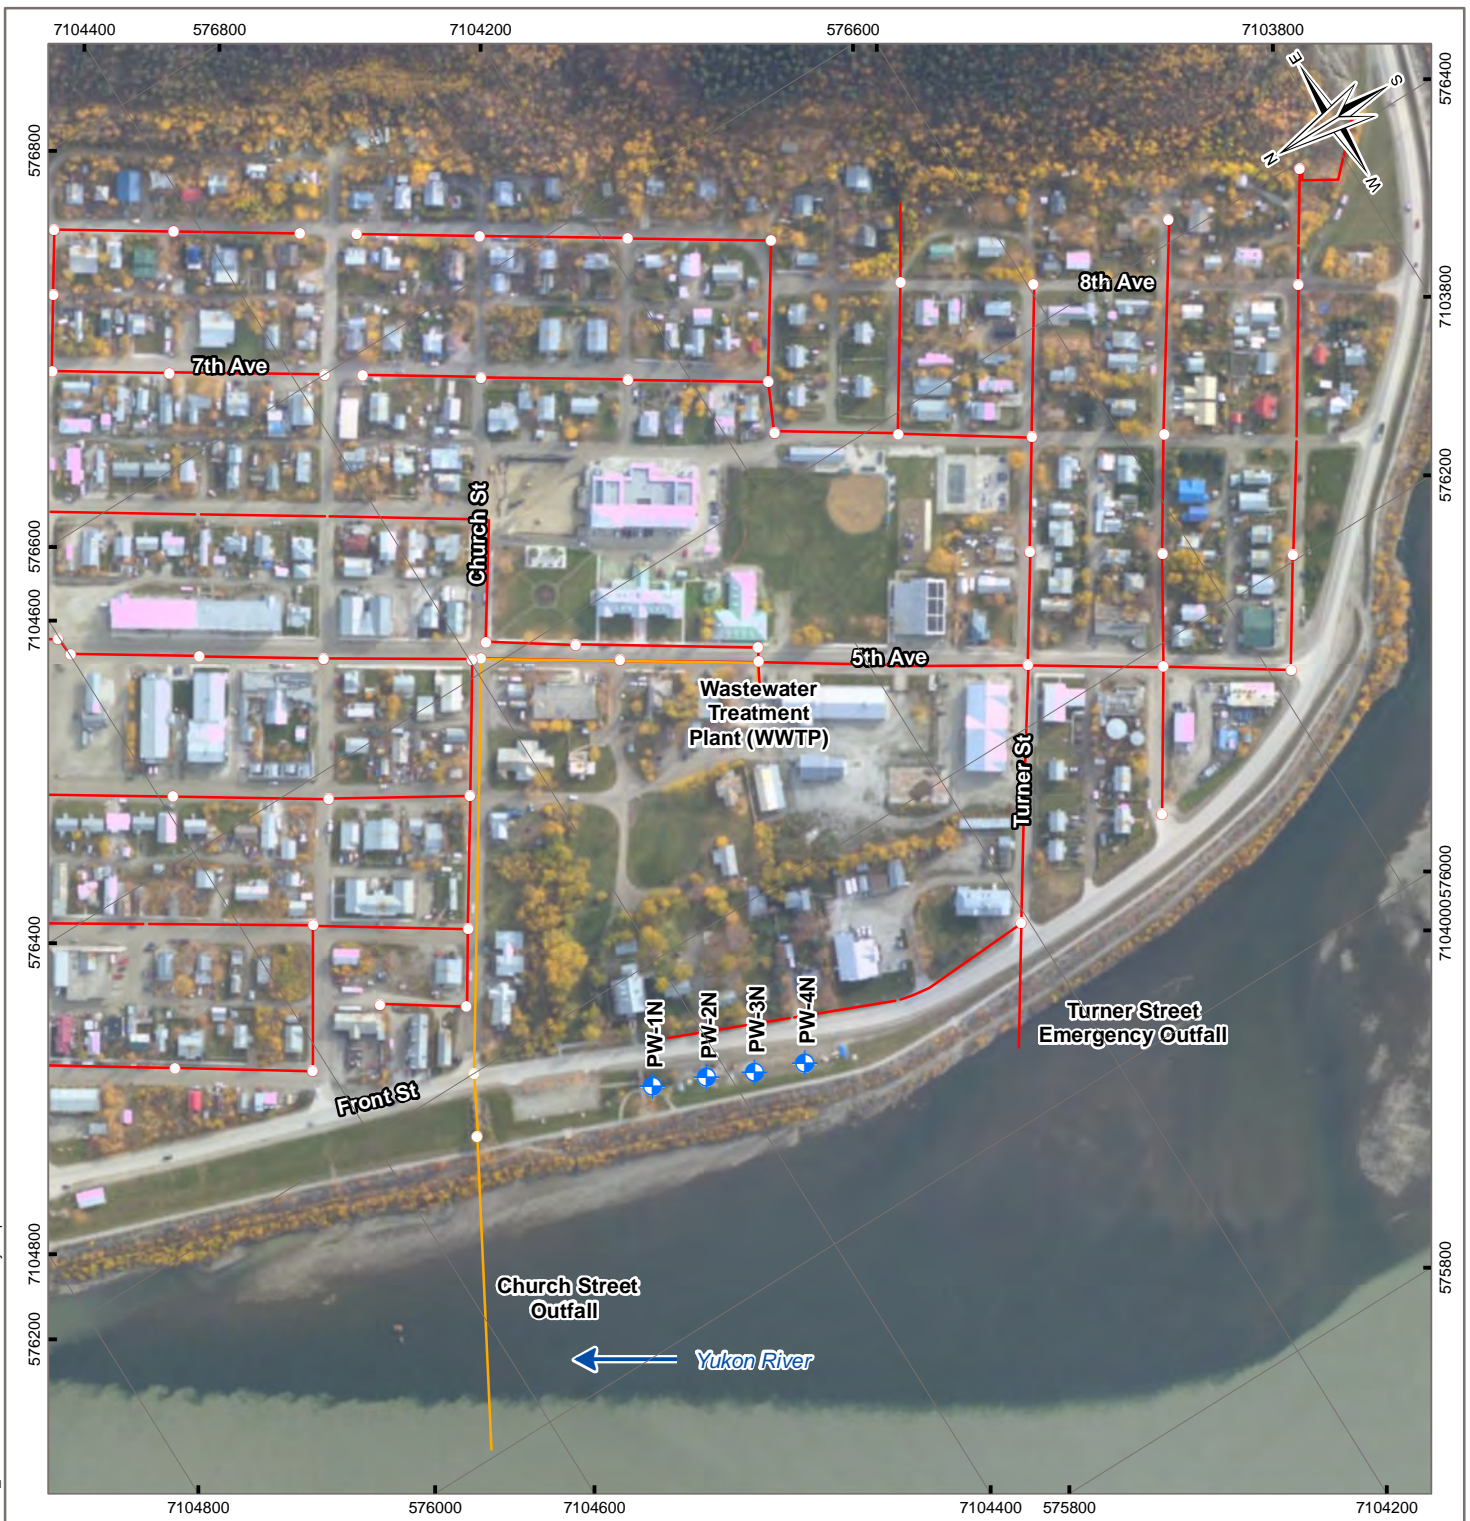
Metres		<b>FILE NO.</b> WENW03020-01_Figure03_Sewer.mxd
<b>OFFICE</b> Tt-VANC	<b>DWN</b> MEZ	<b>CKD</b> SL
<b>DATE</b> October 11, 2017	<b>APVD</b> AS	<b>REV</b> 0
<b>PROJECT NO.</b> ENW.WENW03020-01		<b>Figure 3</b>

- ◆ Water Supply Well
- Outfall Manhole
- Sanitary Manhole
- Sanitary Main
- Wastewater Effluent Outfall
- ➔ River Flow Direction

Residential and commercial buildings in Dawson City are serviced by a network of sanitary sewer services constructed in 1978 and partially replaced in 1993 (Figure 3). There are no known currently functioning on-site sewage disposal systems with the Dawson City area.

Following the treatment process, wastewater normally discharges to the Yukon River opposite Church Street, which is downstream of the water supply wells (Figure 3).

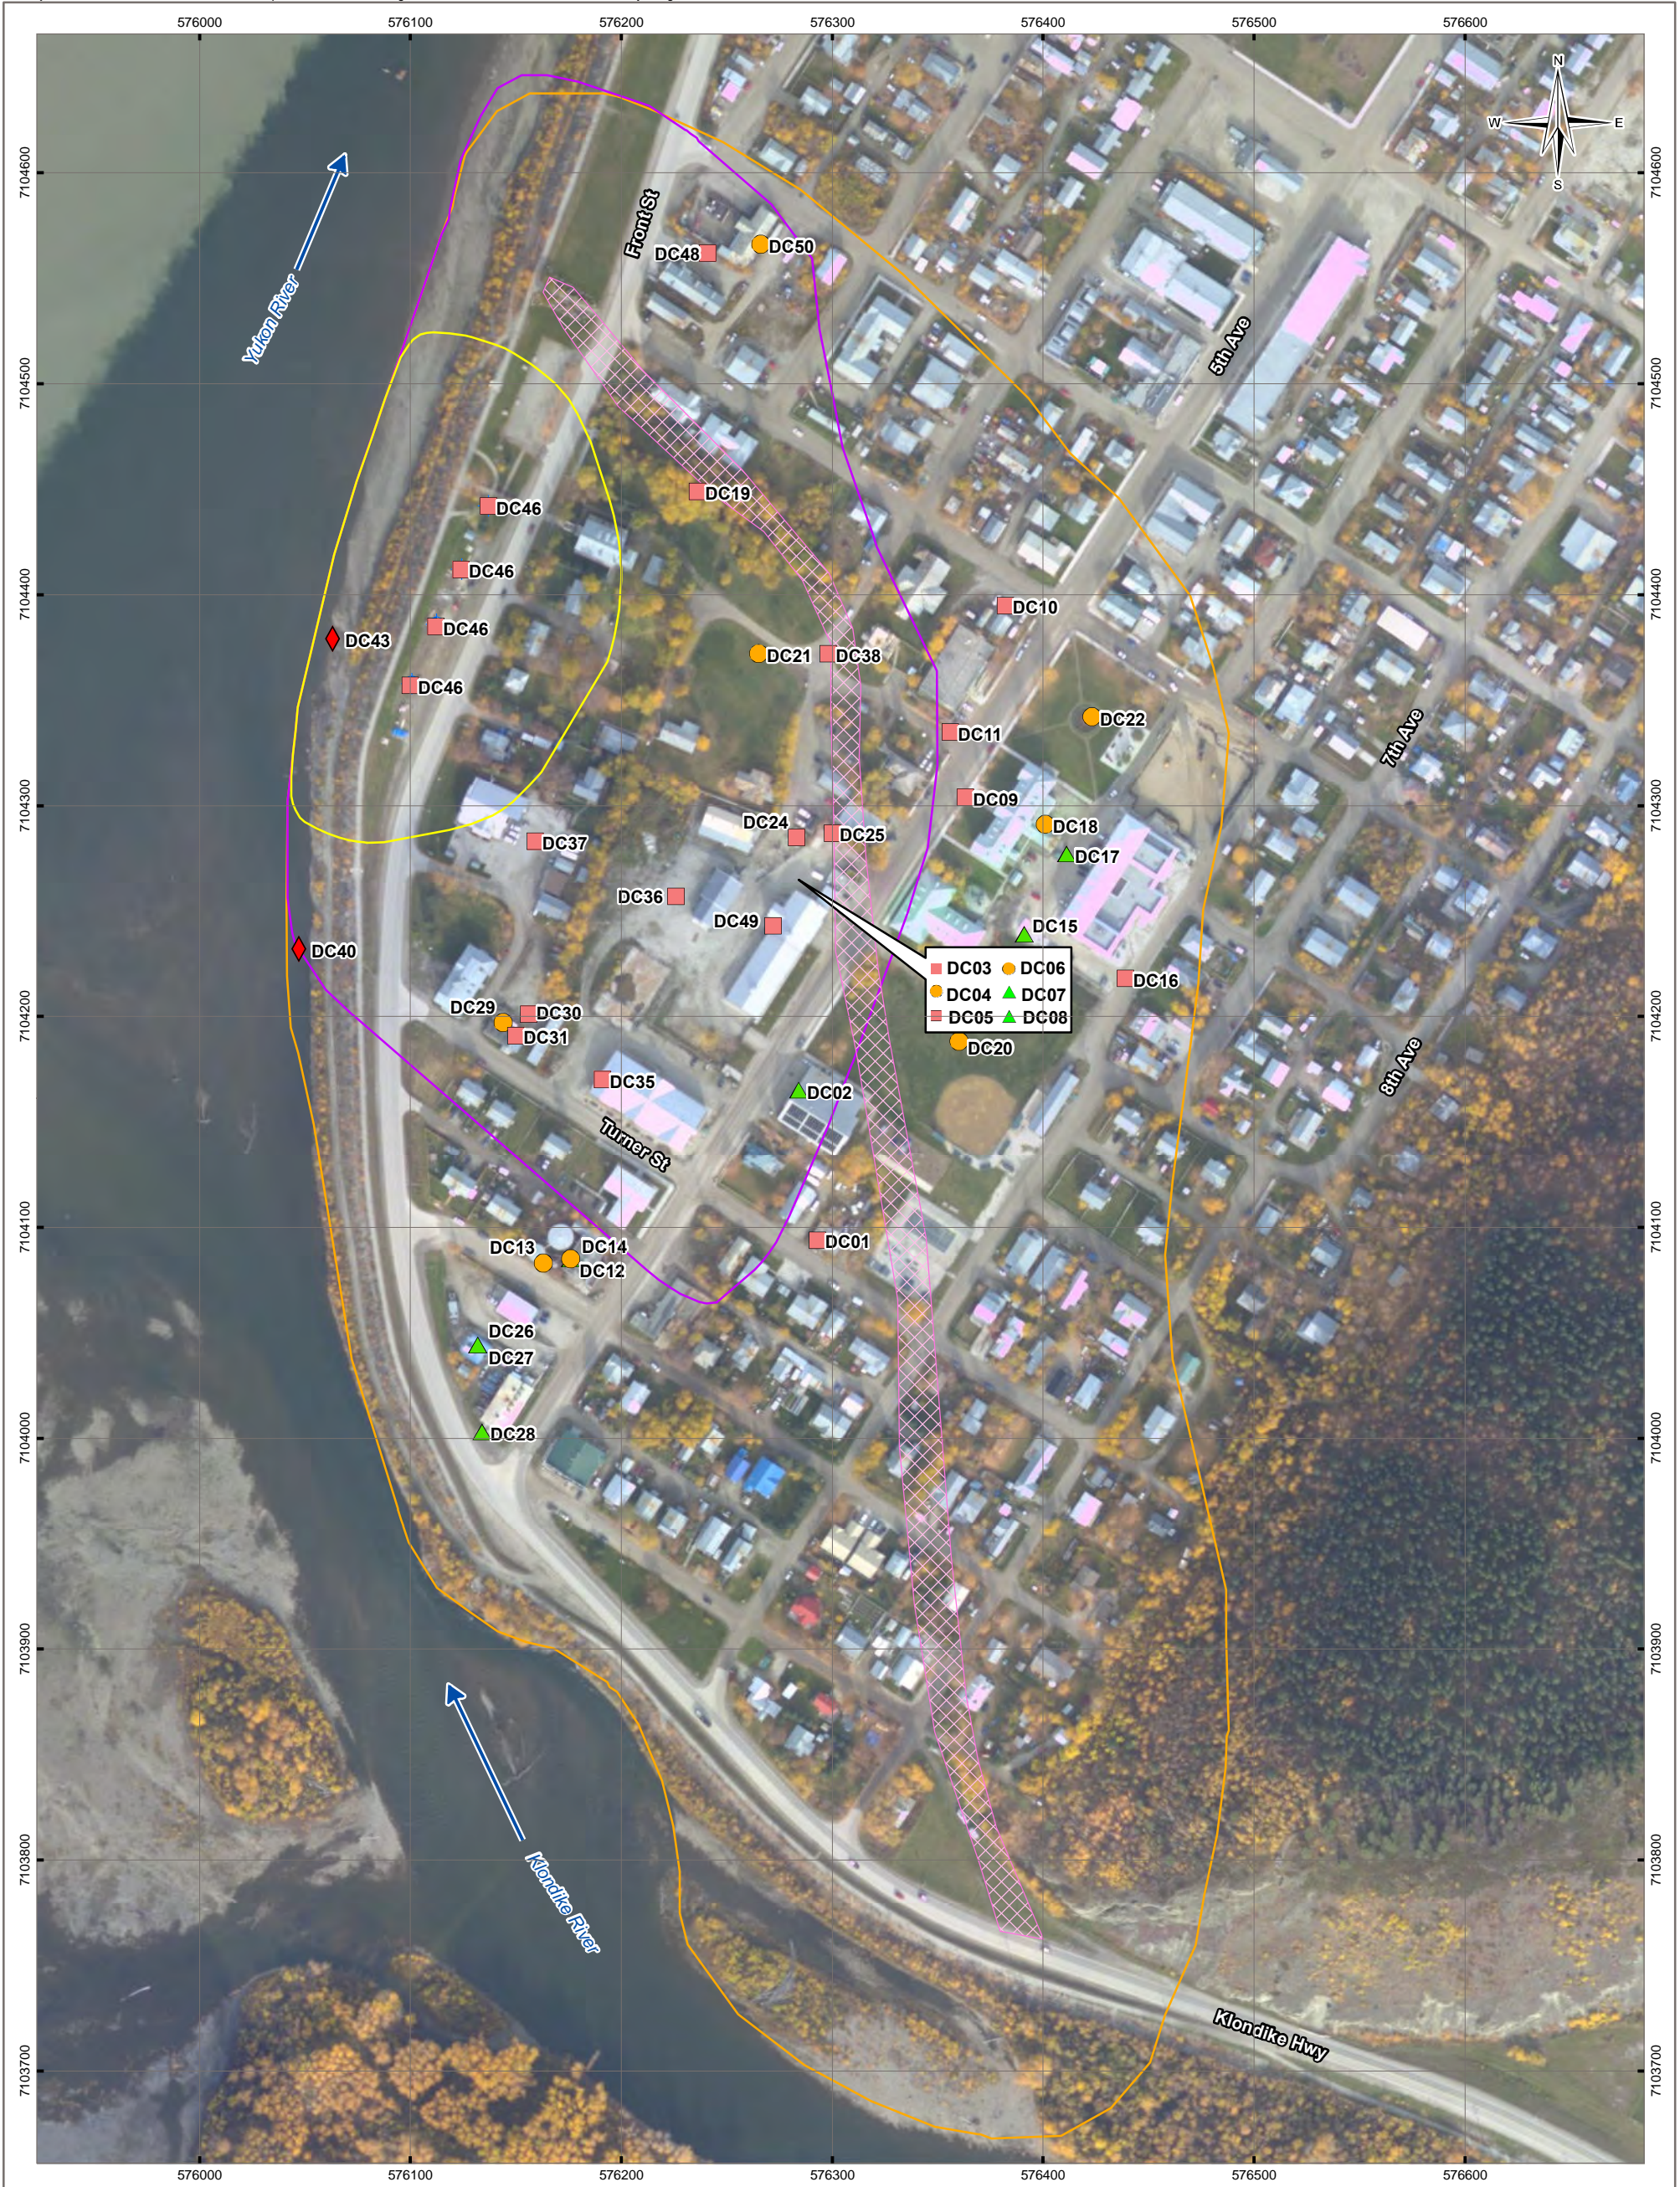
- Water Supply Well
  - Inferred Former Slough Extent
  - 90 Day Capture Zone
  - 1 Year Capture Zone
  - 2 Year Capture Zone
  - River Flow Direction
- Sources of Potential Contamination**
- Low
  - Medium
  - High
  - Very High

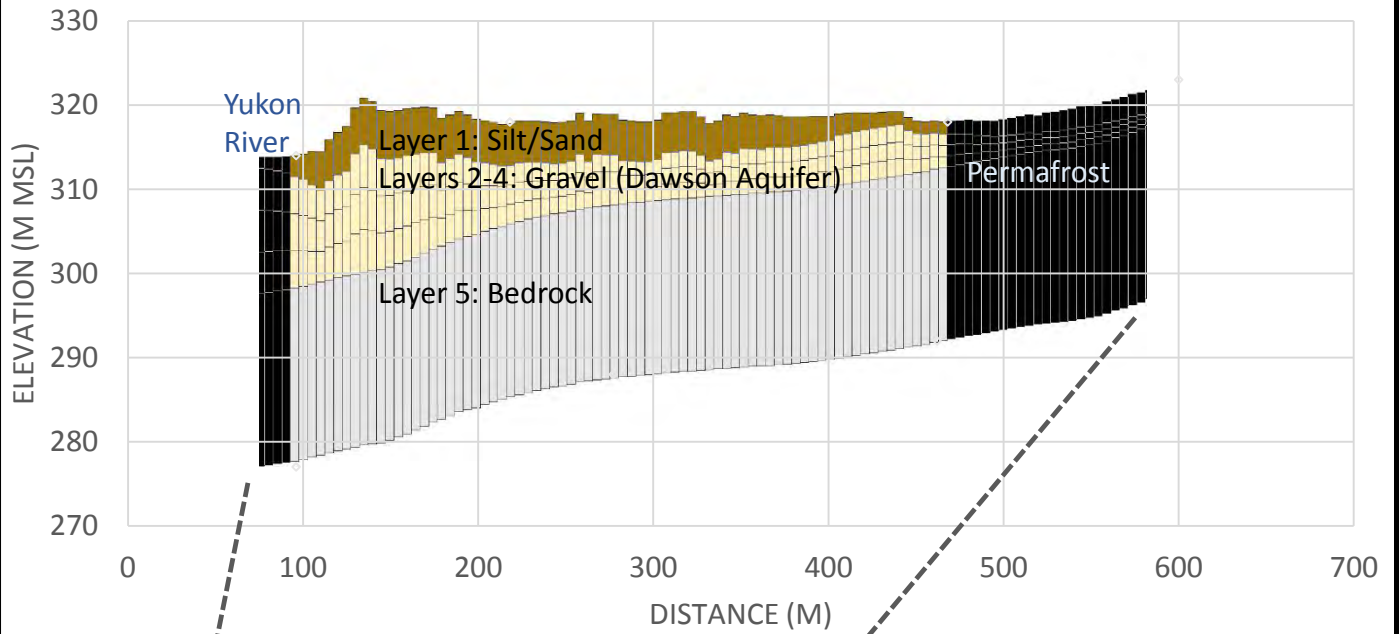
Model Cross-Section at Row 85

# GEOLOGIC SECTION

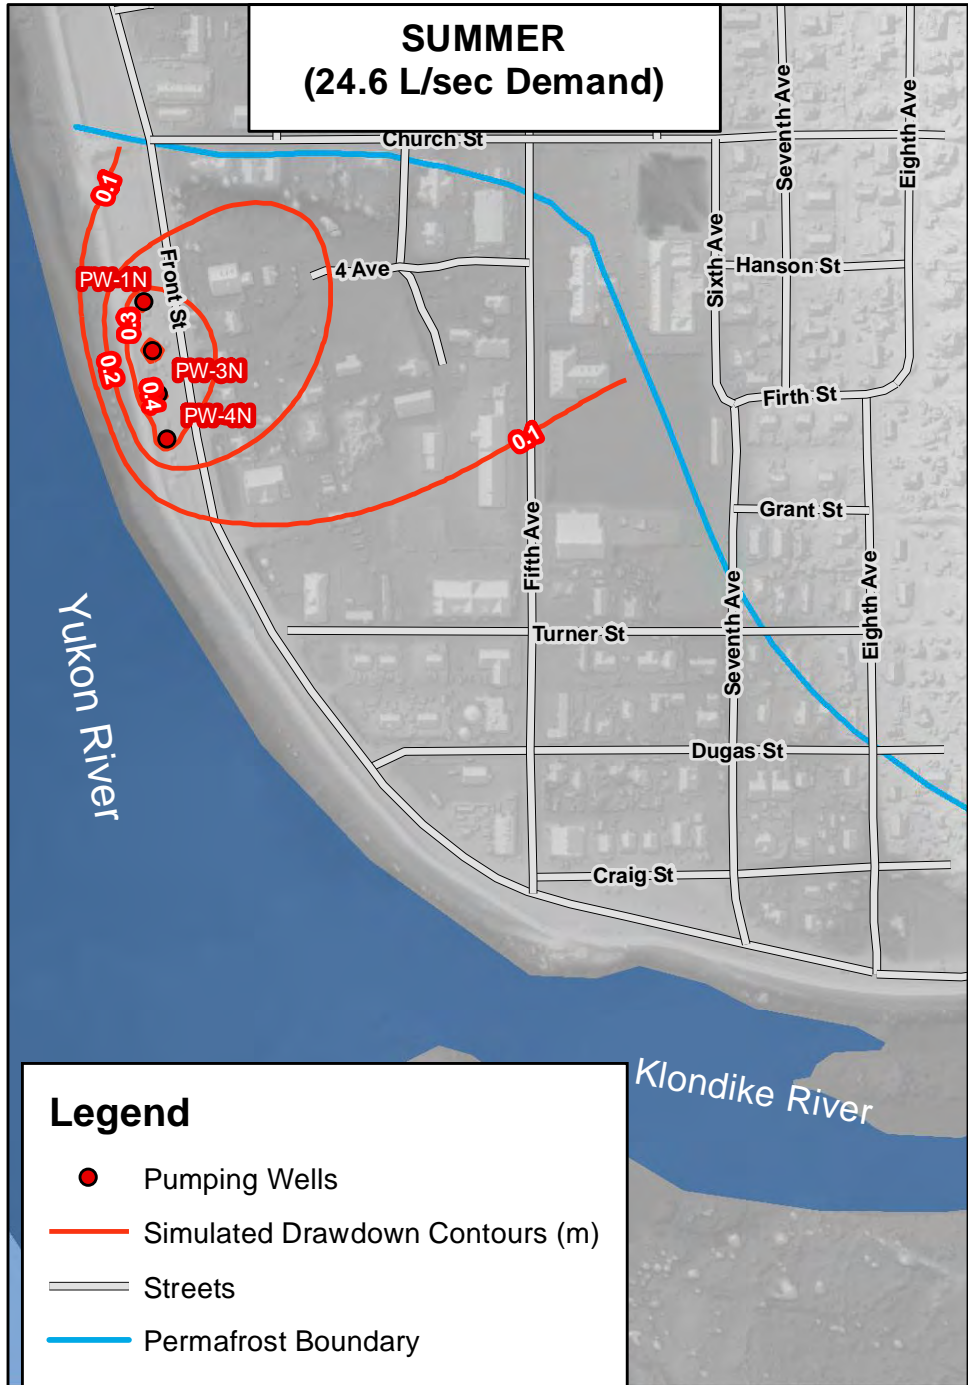
Date: 4/4/2017	Figure 12
	Created by: CKG	
	Checked by: GR

- Pumping Wells
- Simulated Drawdown Contours (m)
- Streets
- Permafrost Boundary

**Simulated Supply-Well  
Seasonal Drawdown**

between 2017 and 2036 demands. During the period from May to September, the total pumping was assumed to be 24.6 Liters per second (L/s). During the winter period from October to April, the water demand was increased to 44 L/s due to increased demand from bleeding. The simulated drawdown resulting from each of these two pumping regimes is presented in Figure 12.
